TECHNICAL REPORT GL-86-17

TECHNICAL EVALUATION REPORTS OF AIRFIELD DAMAGE REPAIR SOLUTION

Final Report

**Field Test of Small Crater Repair Utilizing
Regulated Set Concrete**

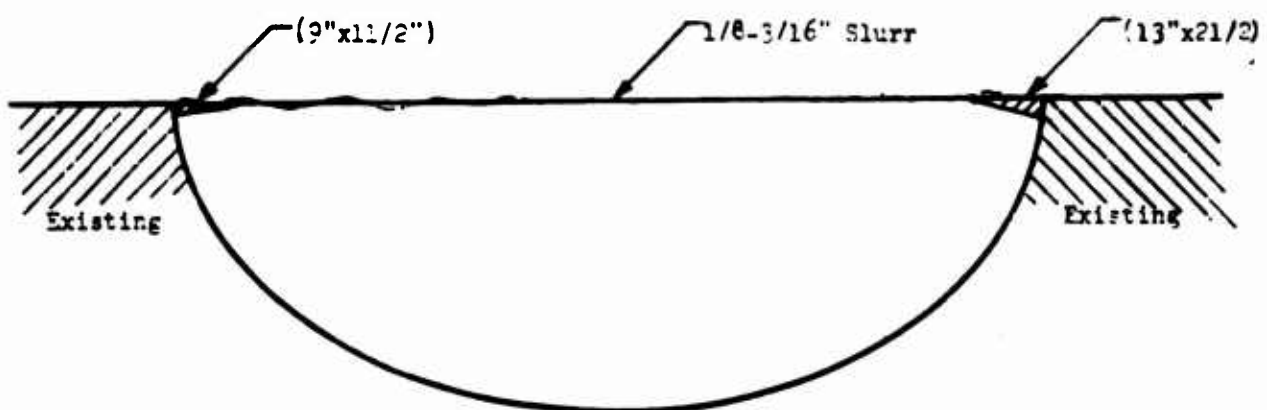
Figure A3. Side view of test strip 1A-1R

Test strip 1A-1R (Figures A1 and A3) completed 50 passes. A depression formed at each end of the test strip where the new cap met the existing surface. The concrete became a soupy mixture and had little aggregate within it. The depression stopped where aggregate was located. Along the path of the test vehicle's tire, a slurr of about 1/8-3/16 in. depth formed. This slurr was caused by frost action over the night, therefore curing did not take place. A high moisture content was found in the top 3/16-in. layer. No deflections or cracks were observed. Figure A2 shows the actual construction of the crater.

e. Analysis: If the crater was given more time to cure during hours of freezing temperature, the depressions would not have occurred. This is also true for the slurr caused by the friction between the crater surface and test vehicle's tire.

a. During very cold or very hot conditions, proper curing methods need to be added to the TEO (Appendix B). The use of a plastic film (10 mil polyethylene) or straw would have produced better curing results.

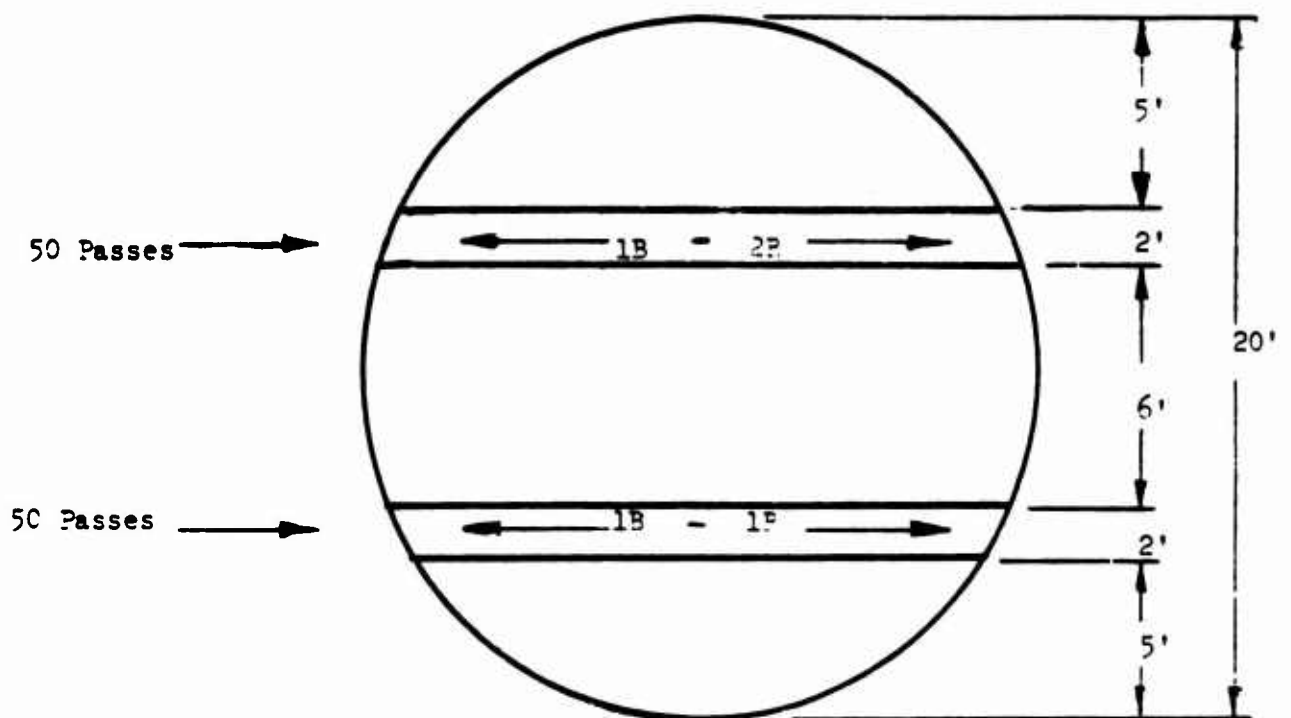
Figure A5. Top view of crater after test

Test strip 1B-1R (Figures A5 and A7) completed 50 passes. No deflections or cracks were observed. The strip showed no signs of being affected by the frost. Figure A6 shows the actual construction of the crater.

Test strip 1B-2R (Figures A5 and A8) completed 50 passes. No deflections or cracks were observed. The strip showed no signs of being affected by the frost. At one edge where the strip meets the existing pavement, there was an uneven lip. Under the weight of the test vehicle, this lip collapsed.

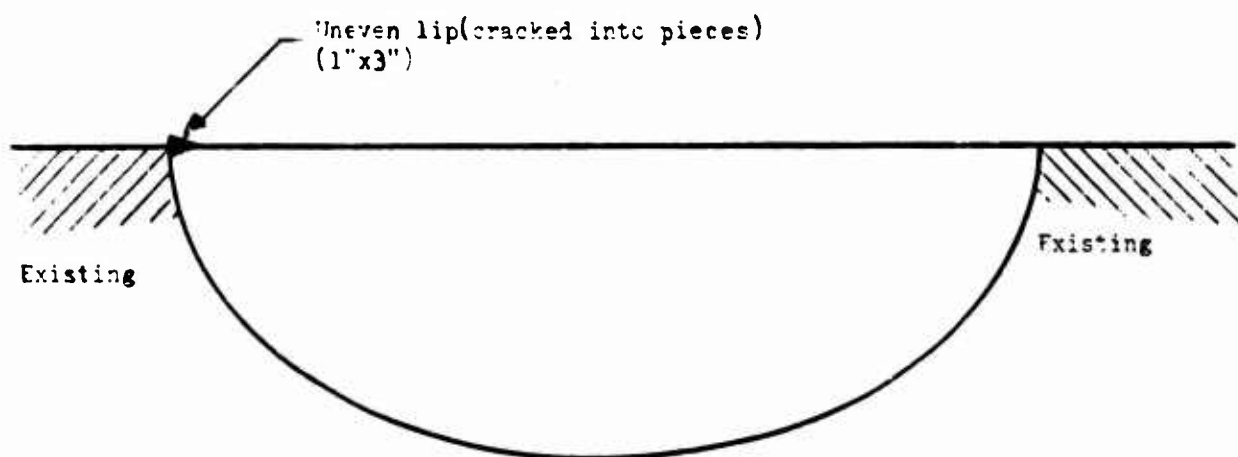
Figure A8. Side view of test strip, 1B-2R

e. Analysis: The concrete cap had no deficiencies except for that of the lip. The moisture content of the debris and aggregate was 18% which caused the poor compaction effort. The subgrade did not affect the results of the test. The crater had 26 in. of standing water prior to the repair. Large aggregate (75-125 mm) was found to be very useful in achieving a 68% CE 55 whereas the compaction would have been very low using water saturated debris only. Vehicles would have been entrapped if nothing was used.

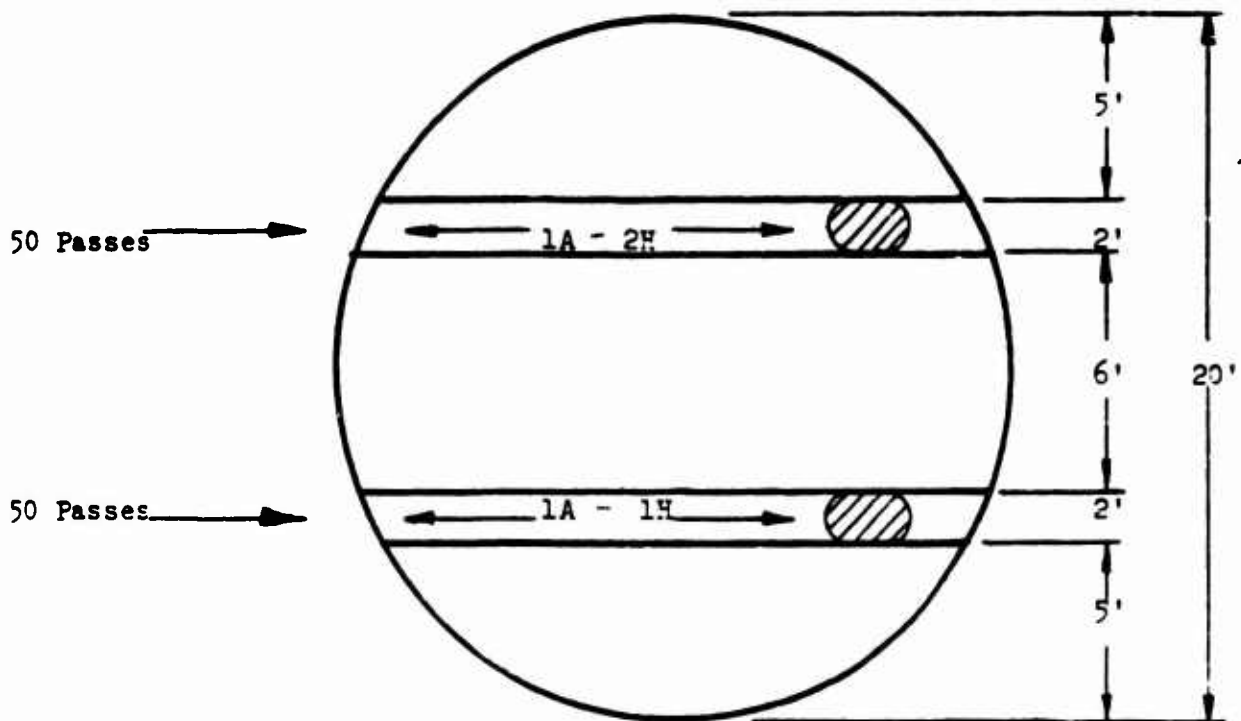
Figure A1. Top view of crater after test

Test Strip 1A-1H (Figures A1 and A3) completed 50 passes. After these passes, water percolated up through the concrete in one area on the strip 23 in. long. No deflection or cracking was observed on the strip. Figure A2 shows actual construction of crater after test.

Test Strip 1A-2H (Figures A1 and A4) completed 50 passes. After three passes, water percolated up through the concrete in one area on the strip 19 in. long. No deflections or cracking was observed on the strip. Figure A5 shows the top view of the crater after test.

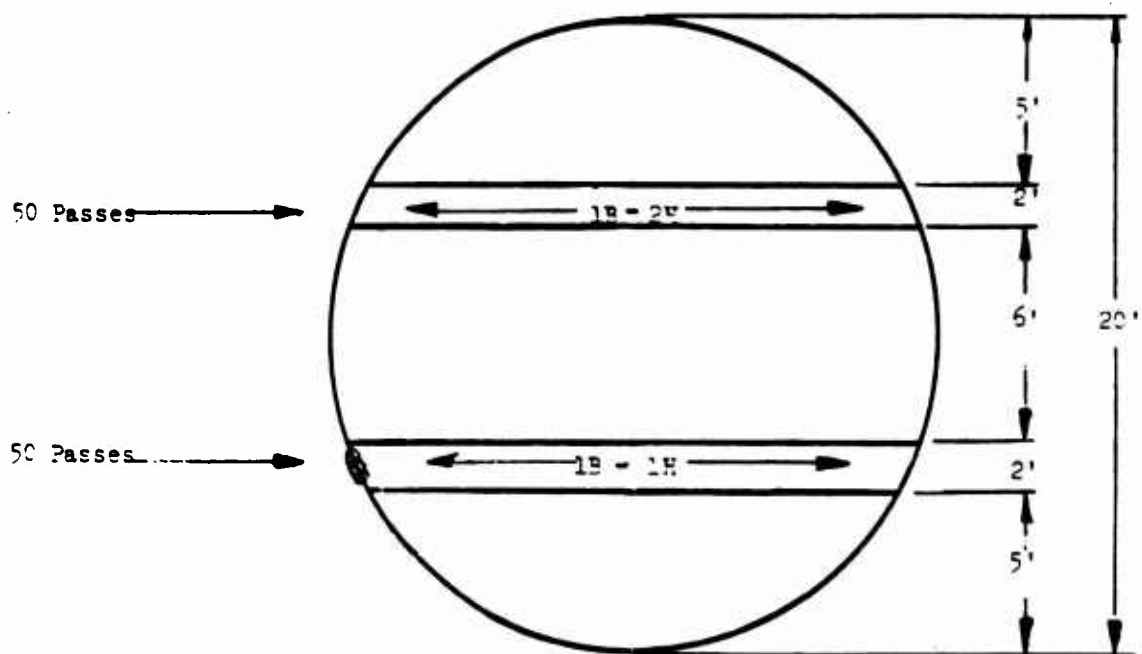
Figure A5. Top view of crater after test

Test Strip 1B-1H (Figures A5 and A7) completed 50 passes. No deflections or cracks were observed. The strip showed no signs of being affected by the cold weather (Photo A14 for illustration). Test Strip 1B-2H (Figures A5 and A8) completed 50 passes. No deflections or cracks were observed. The strip showed no signs of being affected by the cold weather. The only concrete failure occurred at the outer edge of the crater. The existing concrete failed at the edge leaving a small depression. This depression caused the now exposed edge of the new cap to crack off. The entire failure on the cap's edge was 1-1/2 in. deep, 11 in. long, and 4 in. wide.

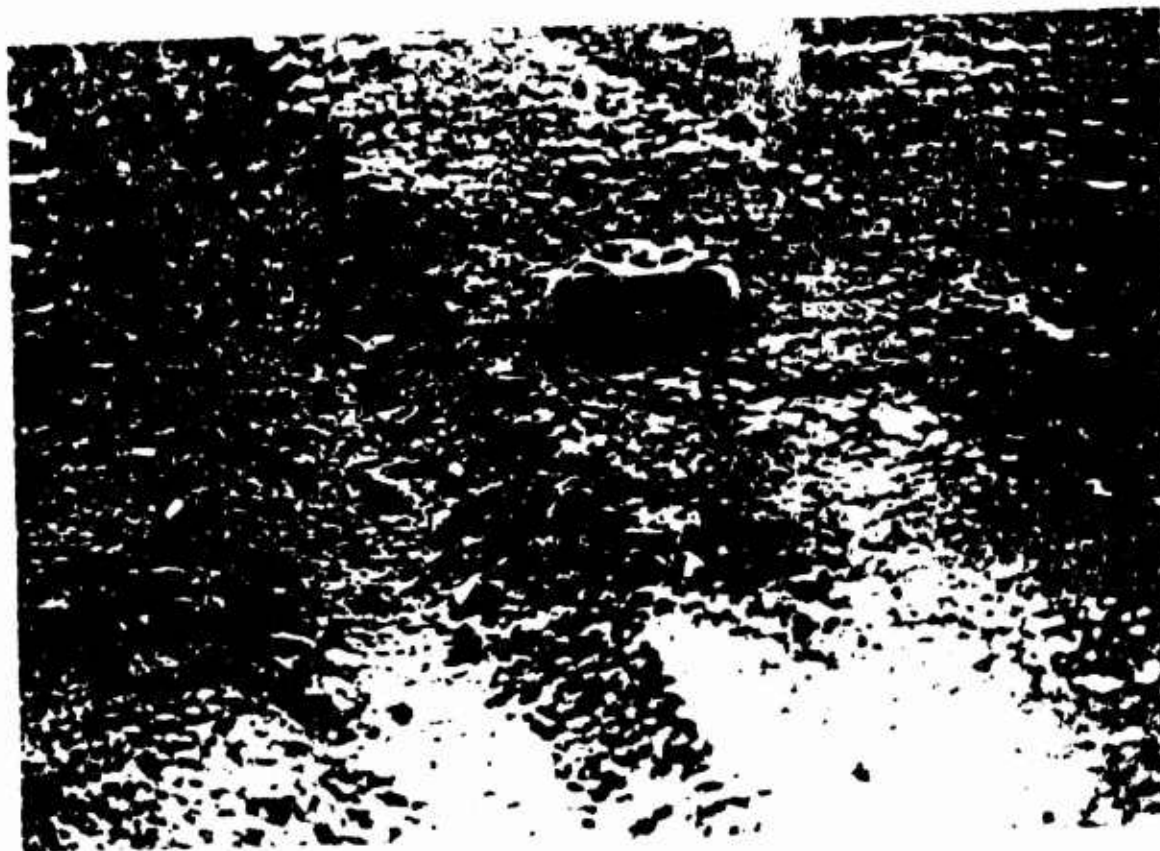
Photo A4. Rutting

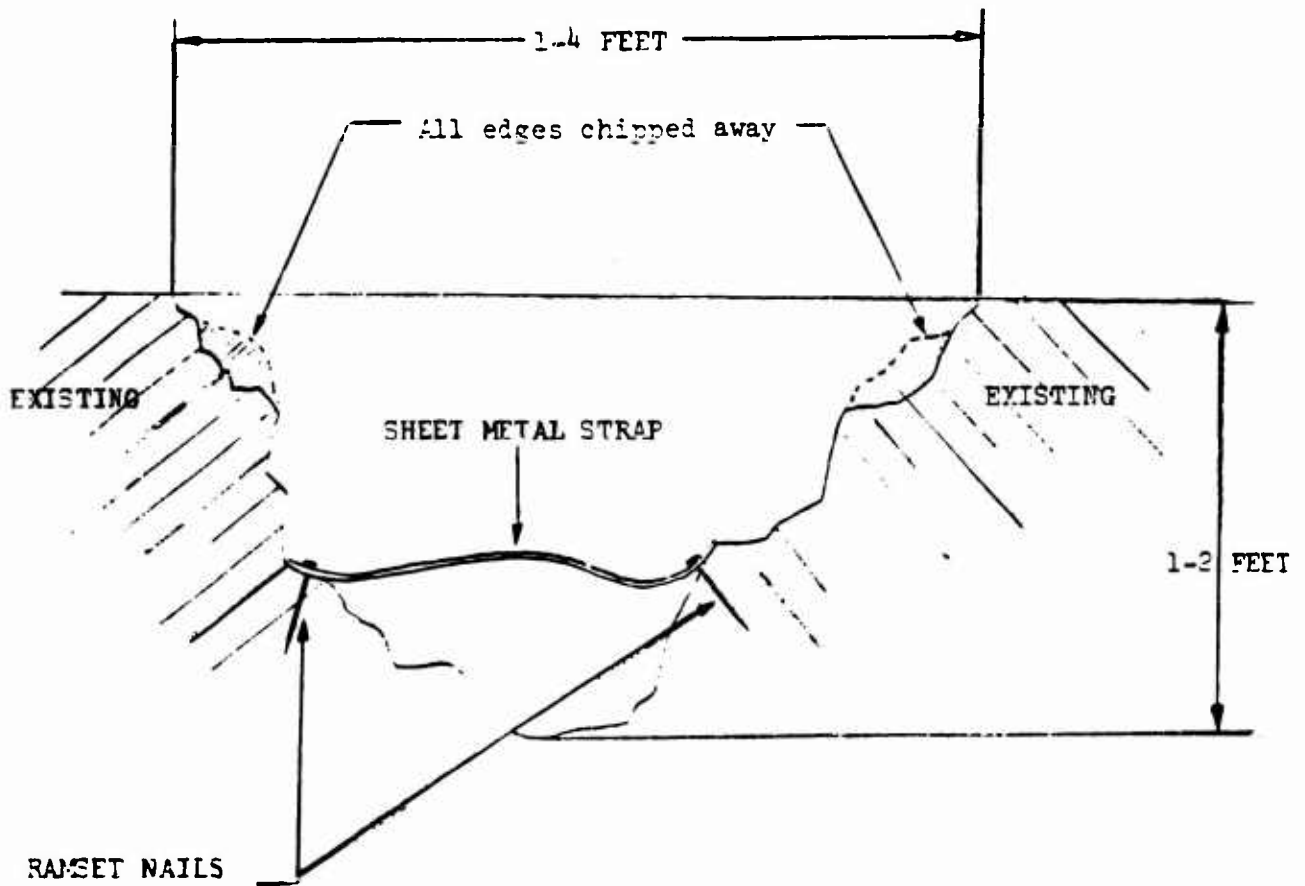
Figure A1. Recommended spall repair using silikal and reinforcement

To make the spall repair permanent, a method of securing the spall to the existing surface is required. Relying on the edges of the spalls is uncertain. Using sheet metal straps secured with ramset nails to the existing spall walls is a solution. Figure A1 illustrates this technique.
